# Manhole Inspection Summary

Manhole # S67M\_\_001MH

**Location** Address: **6418 O' Donnel St.**

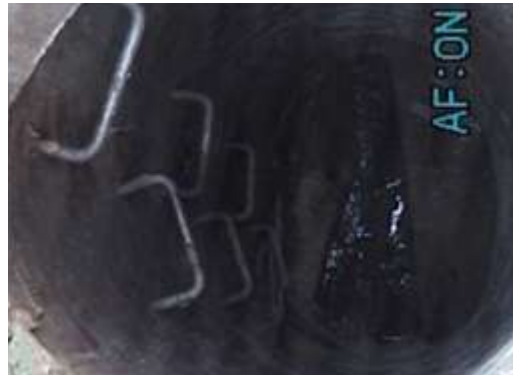
Top View

Comments **OFFSET 3INCHES. 6 O'CLOCK IS CAPPED OFF.**

Type: **Sanitary** Condition: **Cracked** Cover Material: **Cast Iron**

**Frame** Offset: **3** (in.) Condition: ☐ Sound ☐ Cracked ☒ **Leaks**

Condition: ☐ Sound ☒ **Cracked** ☐ Root Intrusion ☒ **Loose Brick** ☒ **Deteriorated**

Infiltration: ☐ None ☒ **Joint** ☒ **Cracks** ☒ **Mortar** ☐ Roots ☐ Wall
